BERRY POND DAM

NH 00105

PHASE I INSPECTION REPORT
NATIONAL DAM INSPECTION PROGRAM

AUGUST 1978

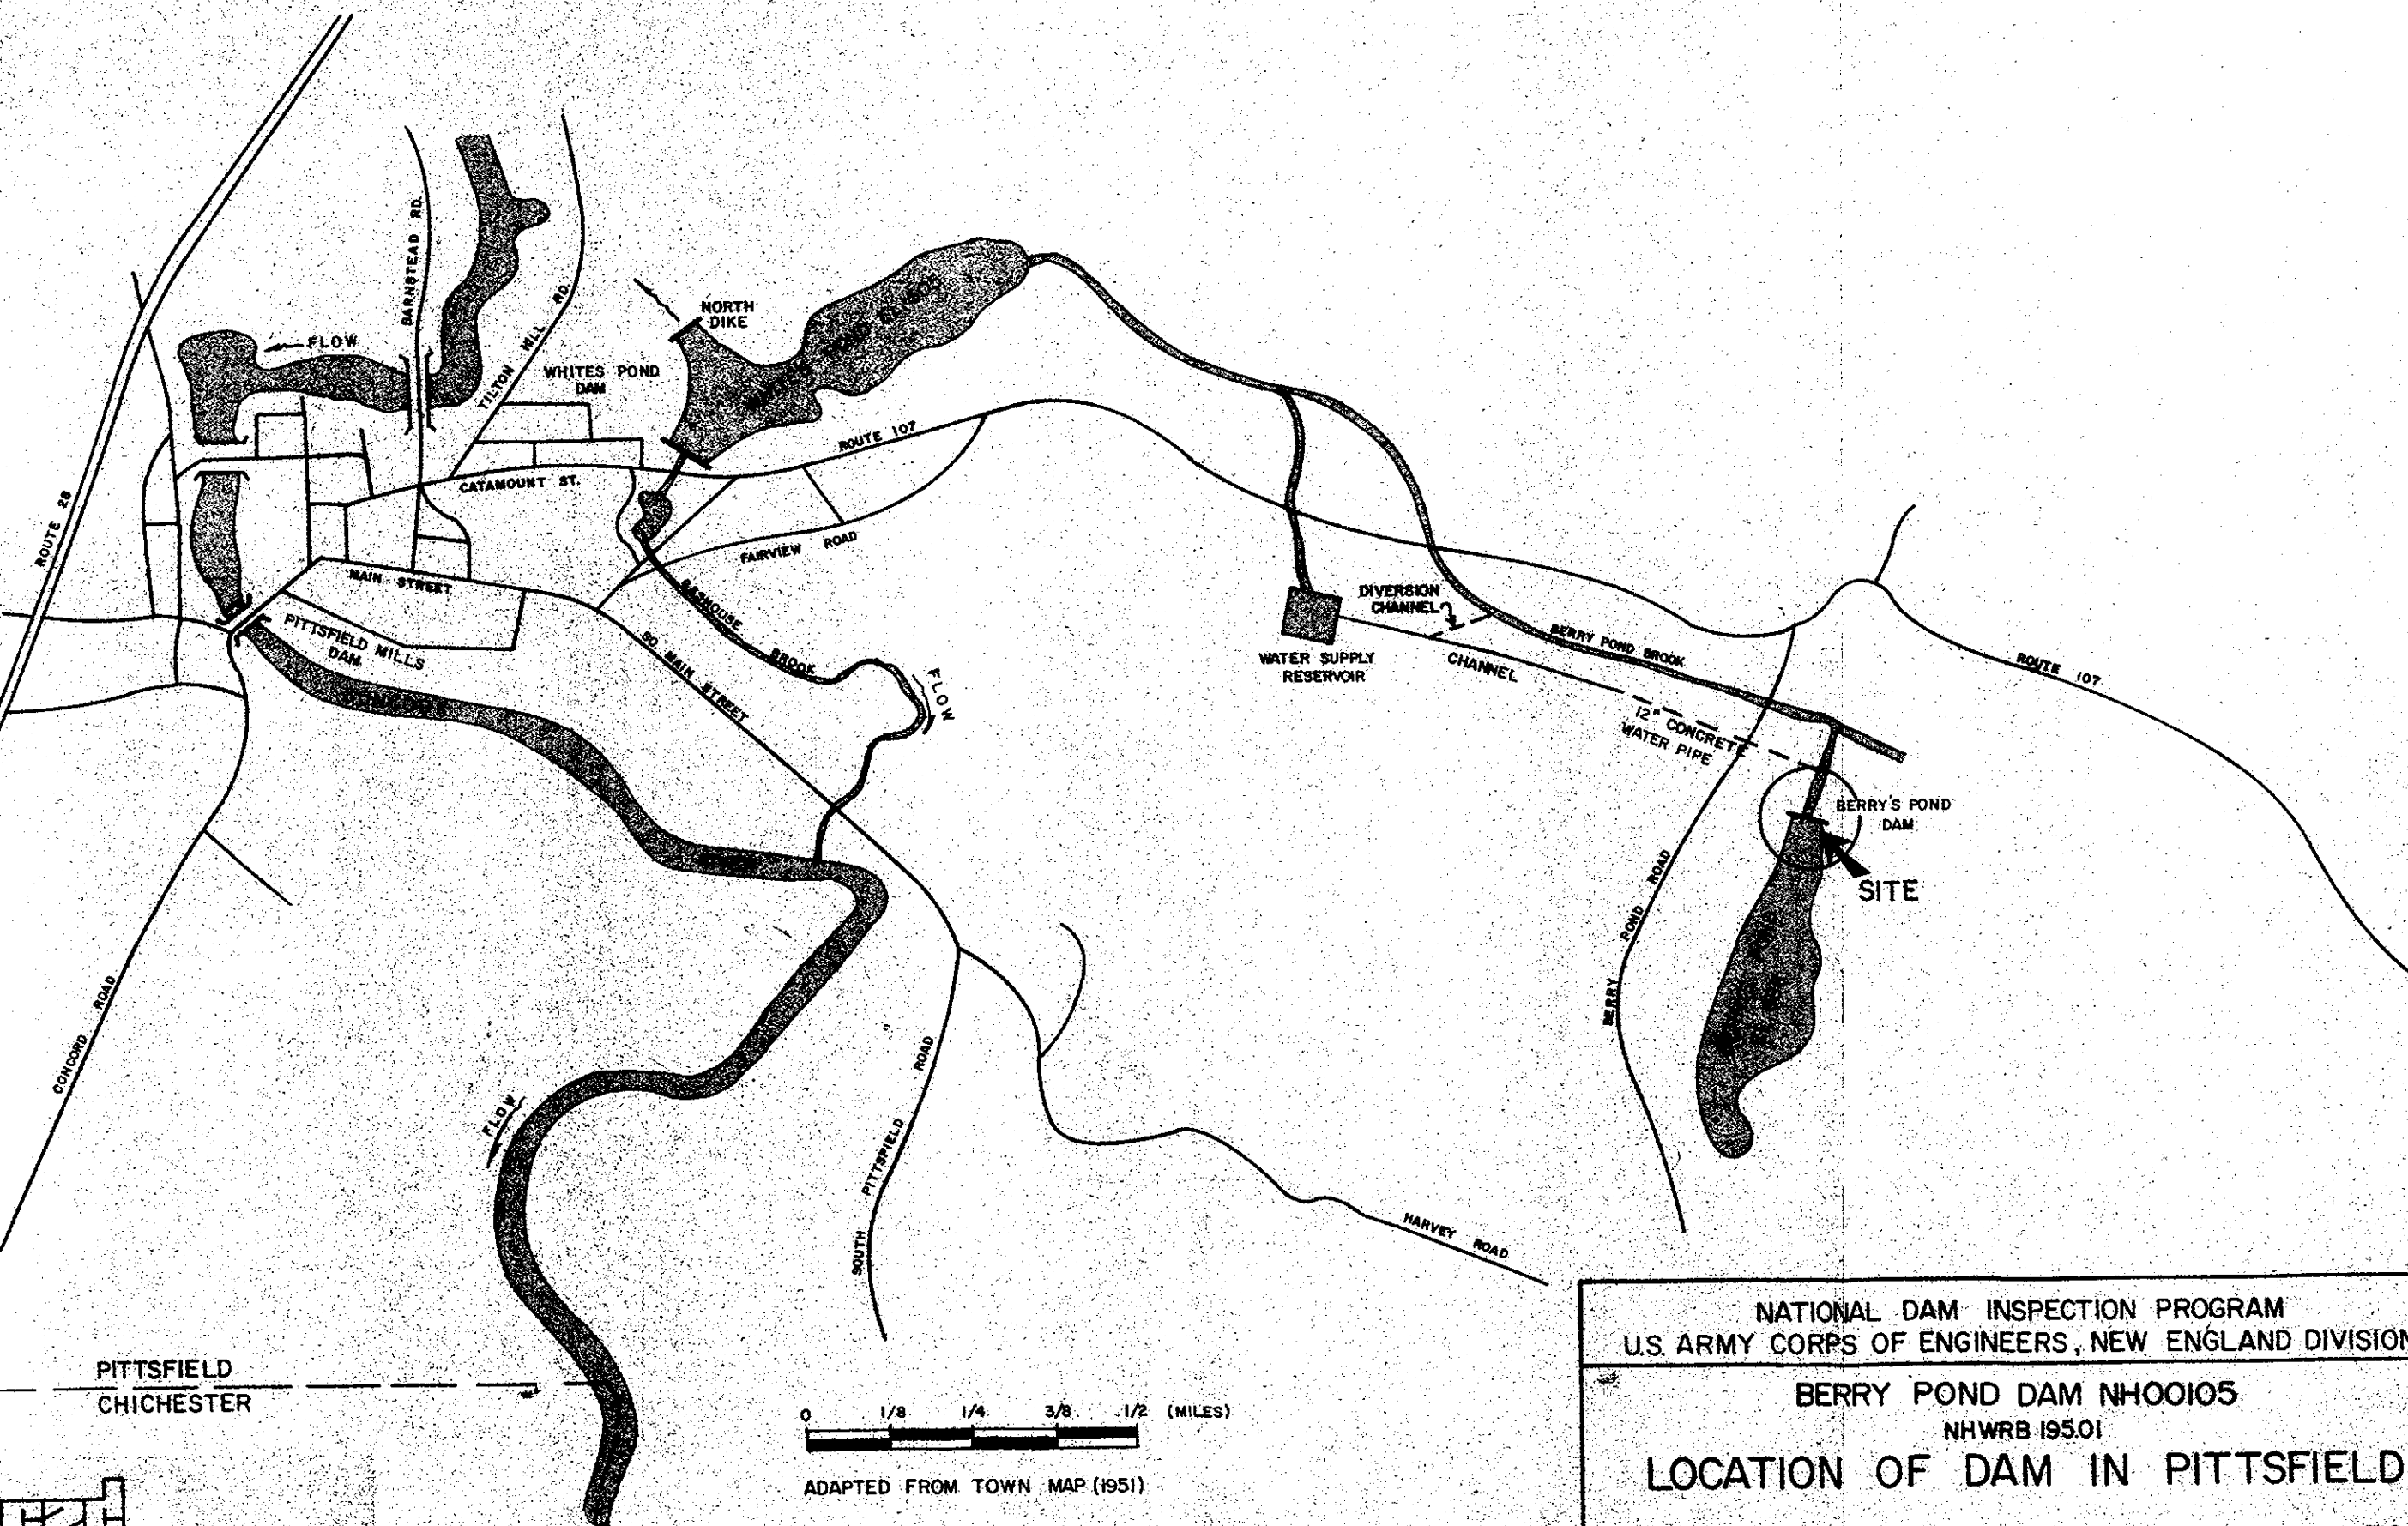
FIG. 1

Berry Pond Dam is located in the Merrimack River Basin at the outlet of Berry Pond approximately 2½ miles southeast of Pittsfield. The locus is shown on the USGS Gilmanton, N.H. quadrangle, and the relation of the dam to other features in Pittsfield is shown in Figure 1 of Appendix B. Berry Brook flows from the dam to the Suncook River.
